STATE OF OHIO
BRIDGE INSPECTION REPORT
ATB-00648-0.639_(0460053)

Inspection Date: 12/08/2025

Inspection Type: Ohio Cursory

B.ID.01: Bridge Number 0460053
B.ID.02: Bridge Name ATB-MR00648-0.639
B.ID.03: Previous Bridge Number

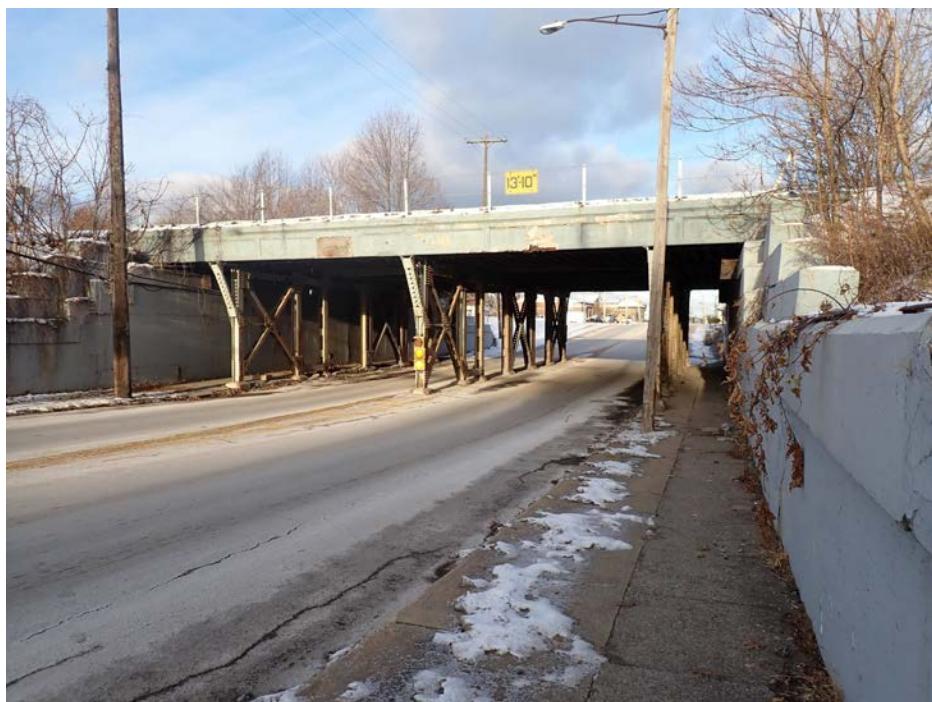
PHOTO 1

Description South bridge elevation, looking northwest.

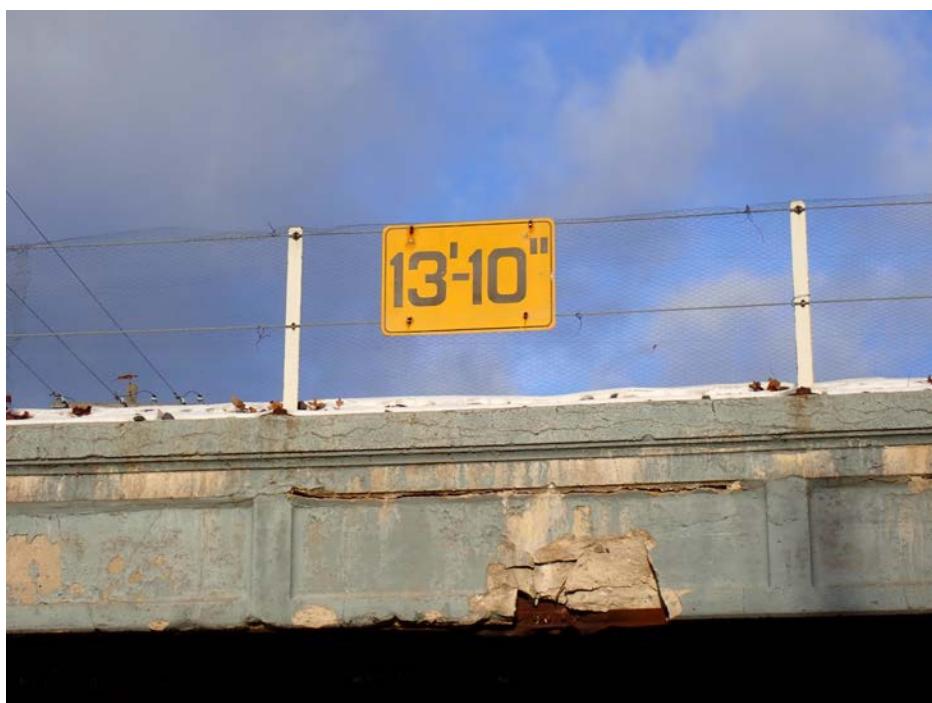
PHOTO 1

The vertical clearance in the northbound direction (Span 3) is signed for 13'-10"; however, the actual minimum vertical clearance was measured at 13'-7" along the left lane line. Note that the south auxiliary fascia beam over this northbound lane has heavy impact damage; however, it does not appear to be recent. The vertical clearance in the southbound direction (Span 2) is signed for 13'-5".

Description South approach 13'-10" vertical clearance sign in Span 3, looking north. Note the measured minimum vertical clearance for the northbound roadway is 13'-7".

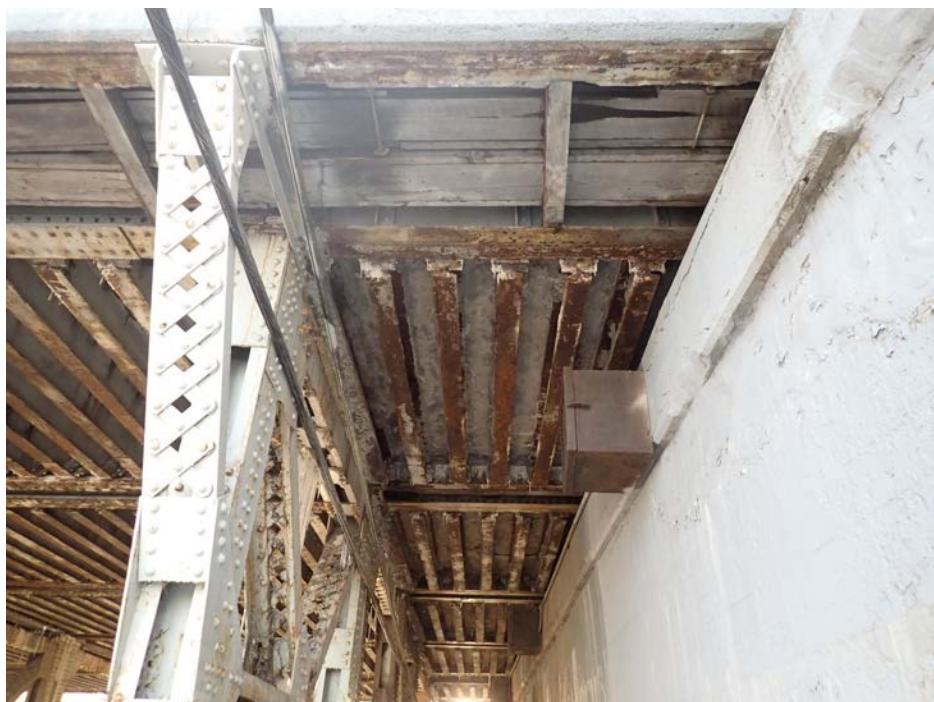
PHOTO 1

Description Superstructure underside in Span 1, looking south.

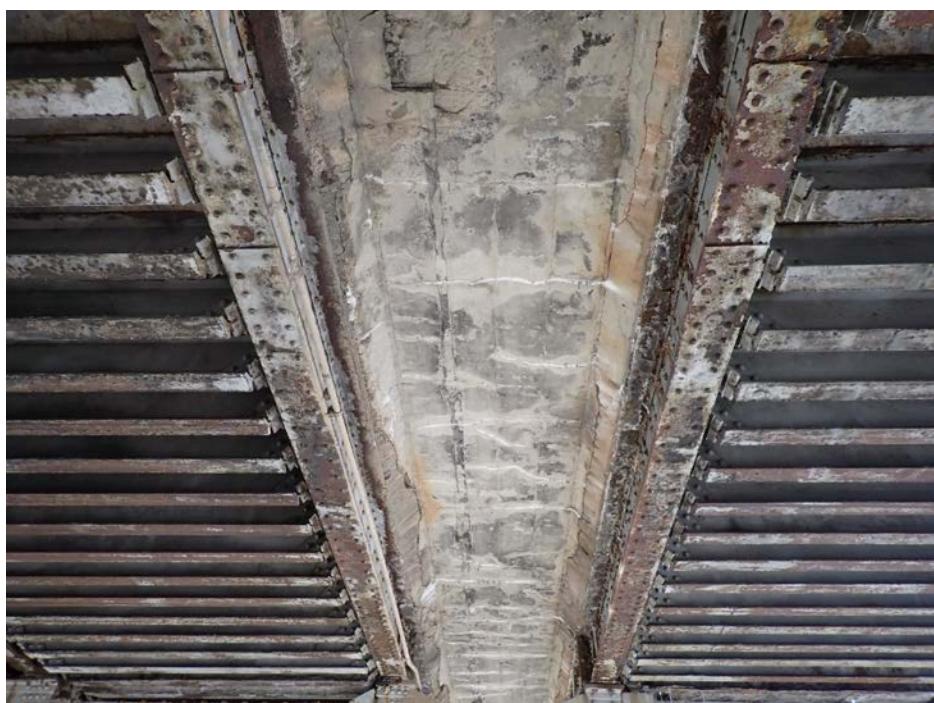
PHOTO 1

The reinforced concrete deck has random medium cracks with light to moderate efflorescence, minor to moderate delaminations, and spalls with exposed reinforcement. The deck underside between Girders 8 and 9 has medium transverse cracks with light to moderate efflorescence throughout. There is evidence of leakage through the deck in isolated locations.

Description Typical transverse cracks with efflorescence in the underside of the deck in Span 2 between Girders 8 and 9, looking east.

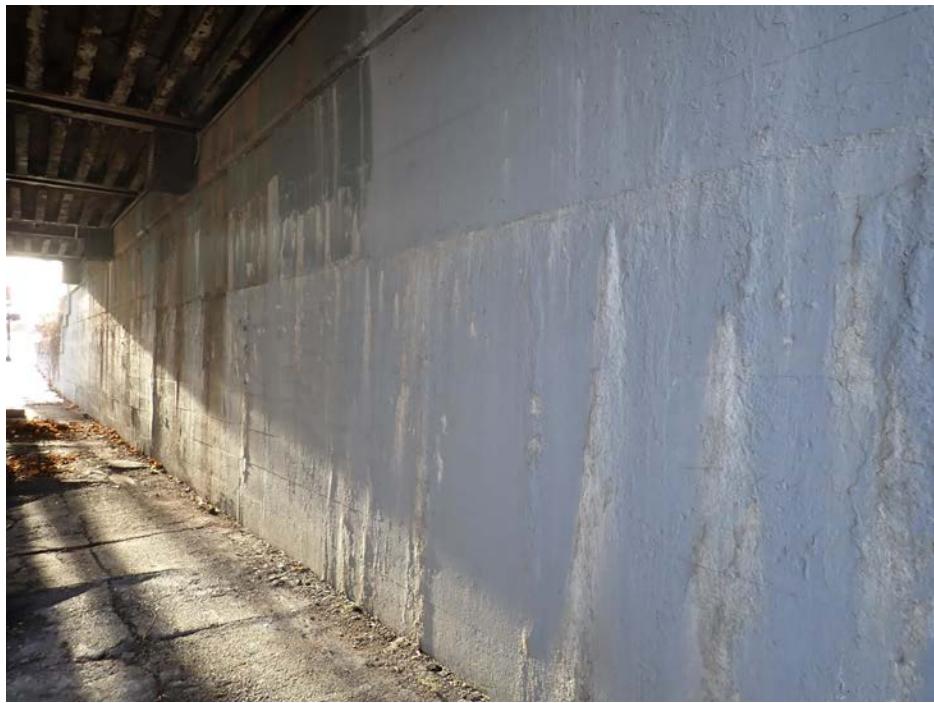
PHOTO 1

Description Rear Abutment elevation, looking southwest.

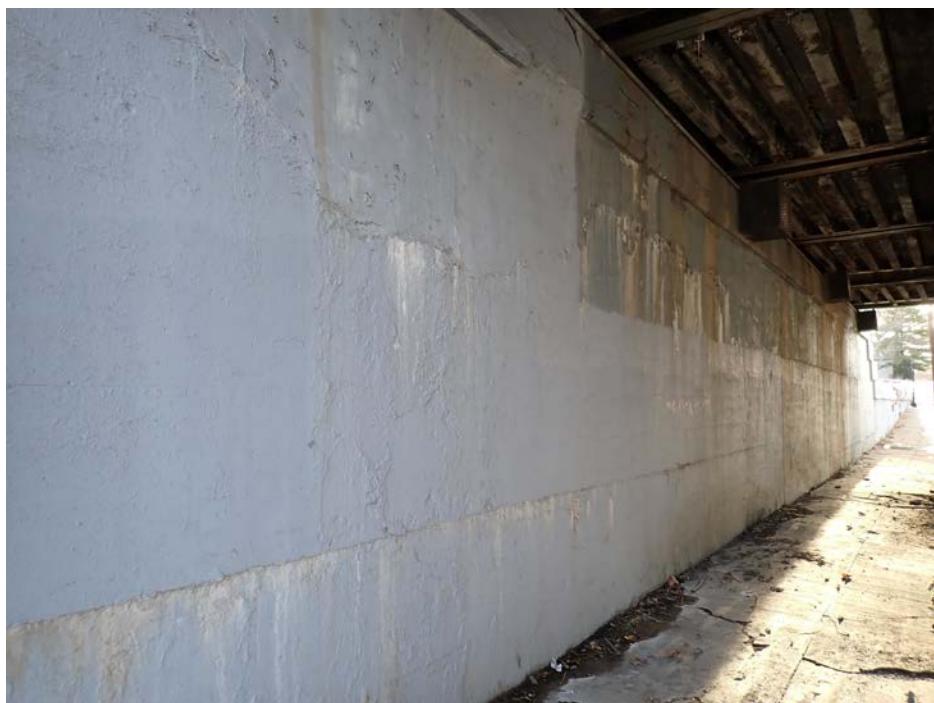
PHOTO 2

Description Forward Abutment elevation, looking southeast.

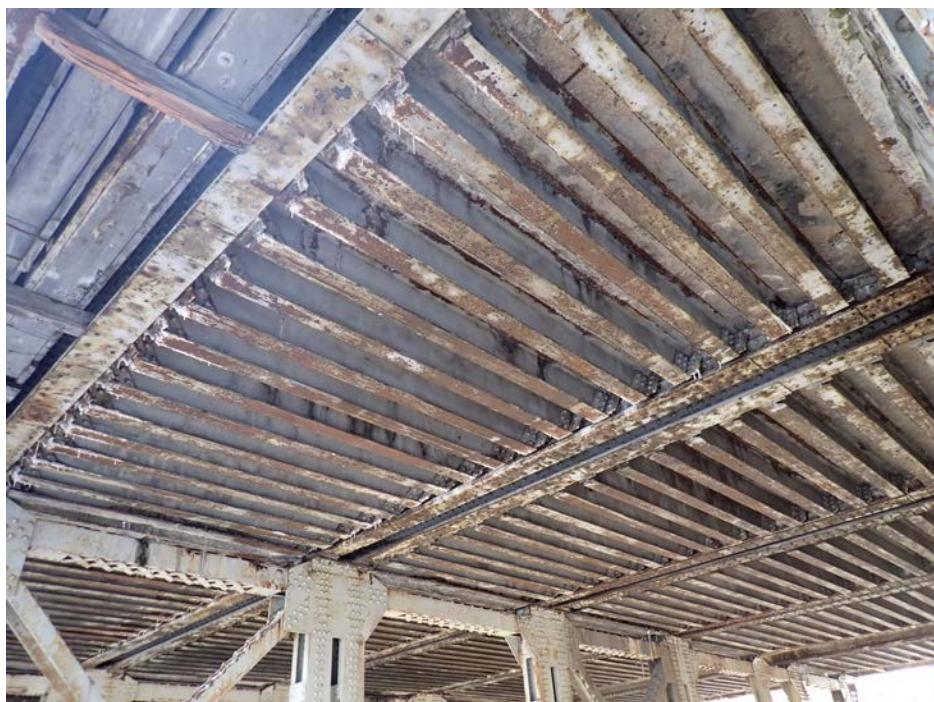
PHOTO 2

Description Superstructure underside in Span 2, looking southeast.

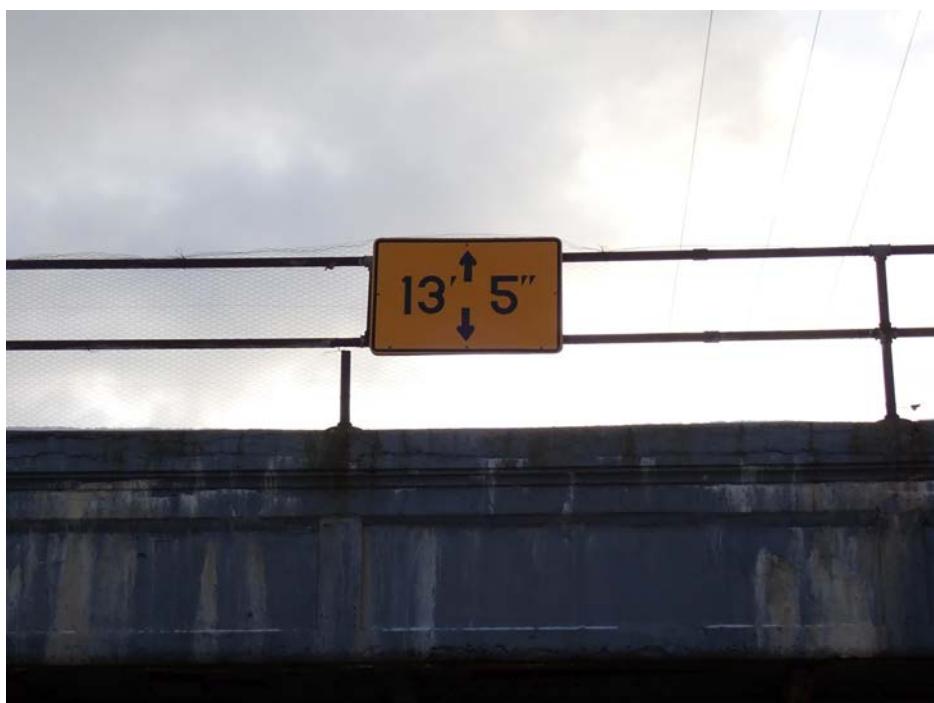
PHOTO 2

Description North approach 13'-5" vertical clearance sign in Span 2, looking south.

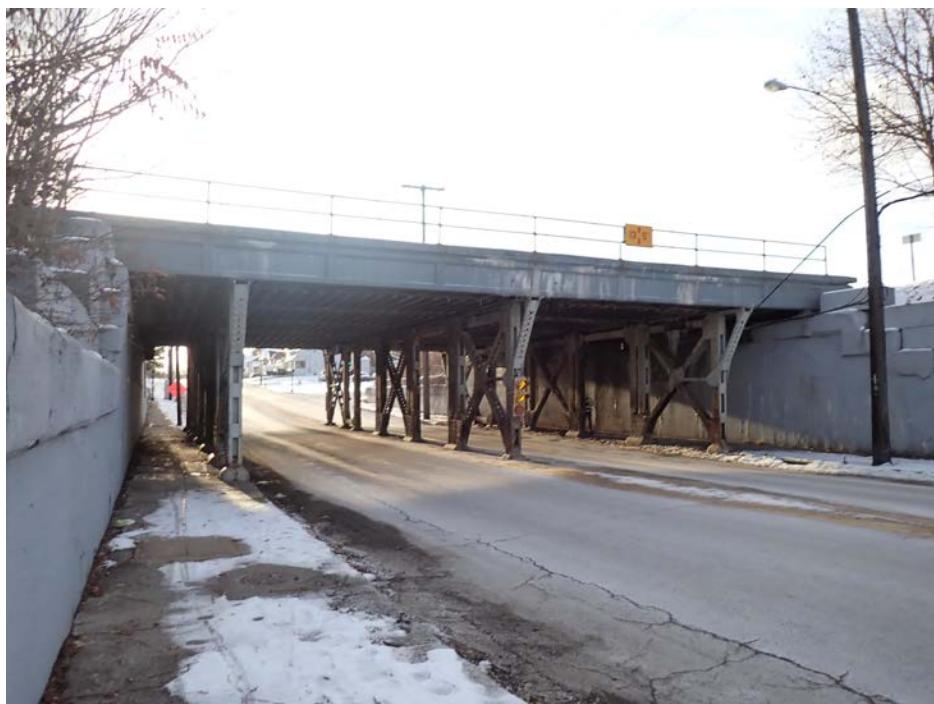
PHOTO 2

Description North bridge elevation, looking southwest.

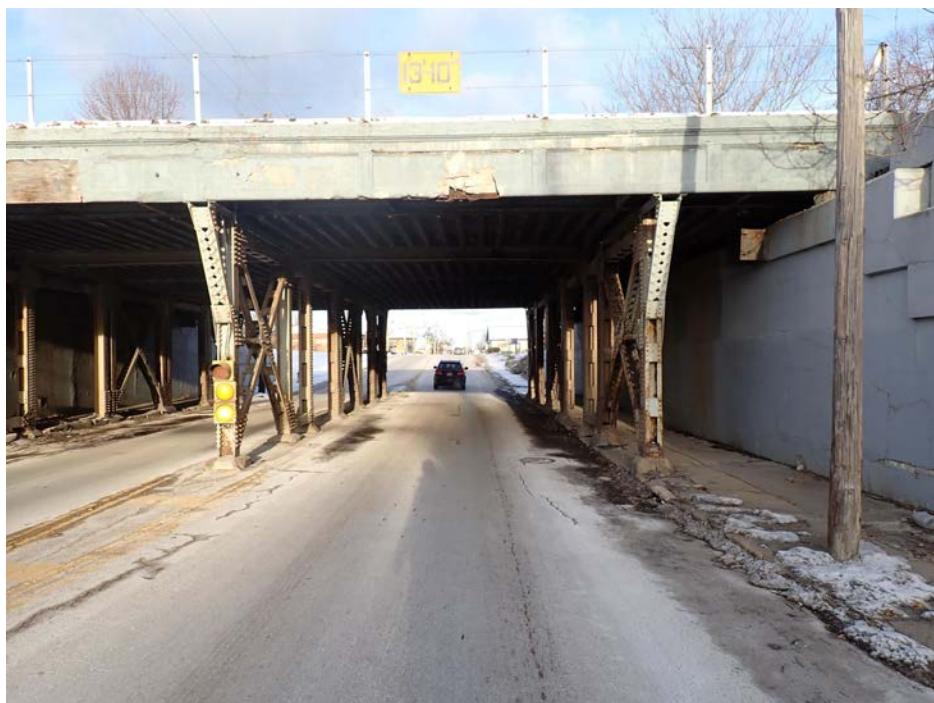
PHOTO 3

Description Roadway under view in Span 3 (Lake Avenue), looking north.

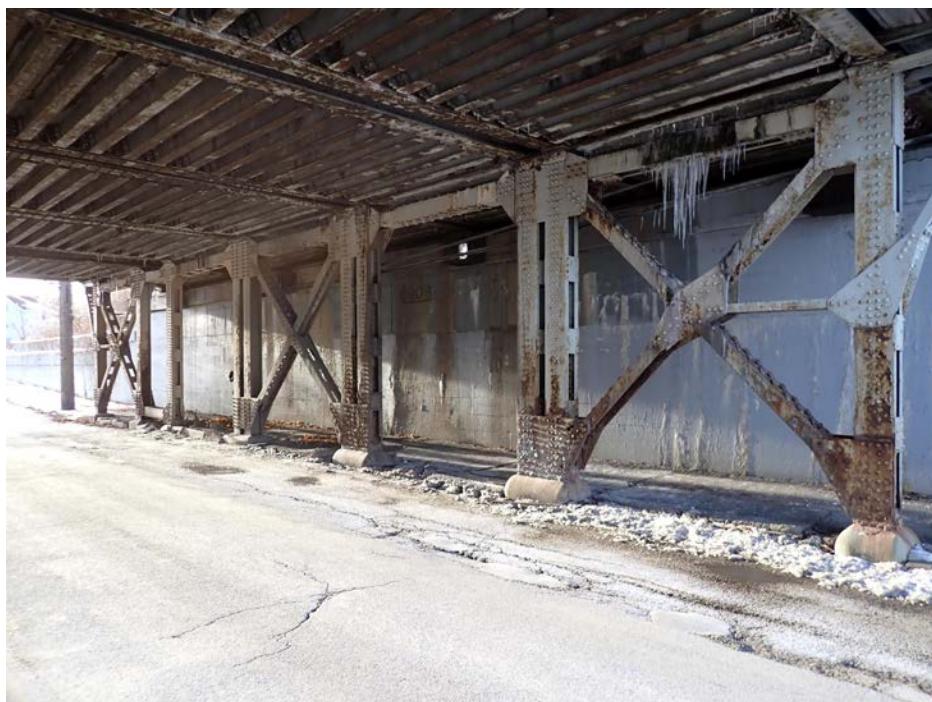
PHOTO 3

Description Pier 1 elevation, looking southwest.

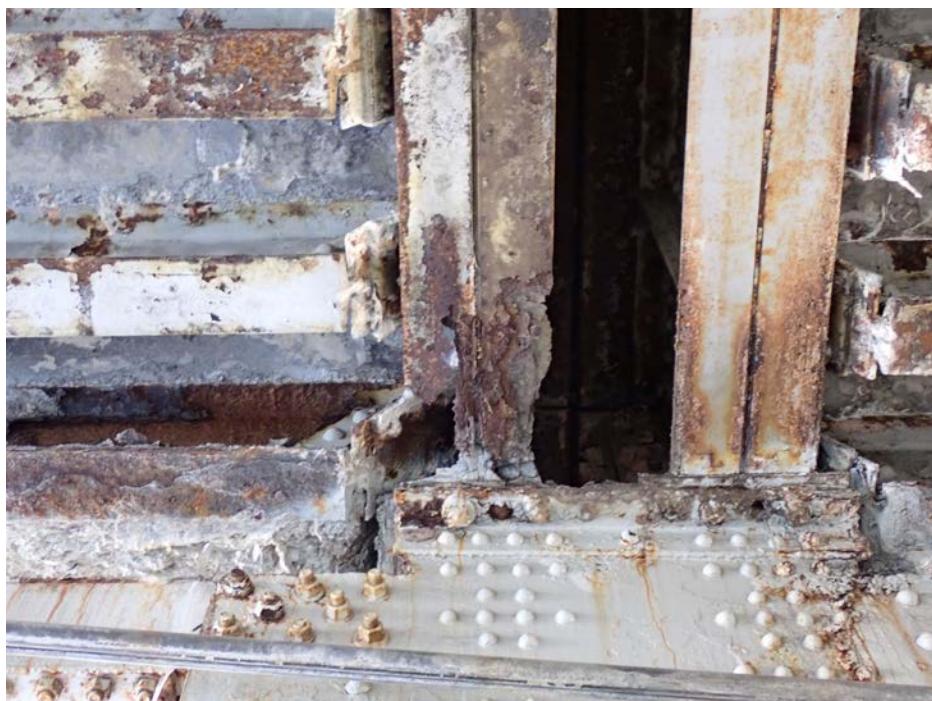
PHOTO 3

The girders typically have widespread paint failure with minor to moderate laminate corrosion. Girder ends at interior piers have heavy laminate corrosion and section loss on the bottom flanges with up to 4" wide edge loss at isolated locations, typically worst in Spans 2 and 3 at the locations between the pier and the start of the first bottom flange cover plate. There are isolated missing rivets between pier bearing/fill plates and girder bottom flanges at interior piers.

Description Edge loss of Girder 2 bottom flange in Span 1 at Pier 1, looking east.

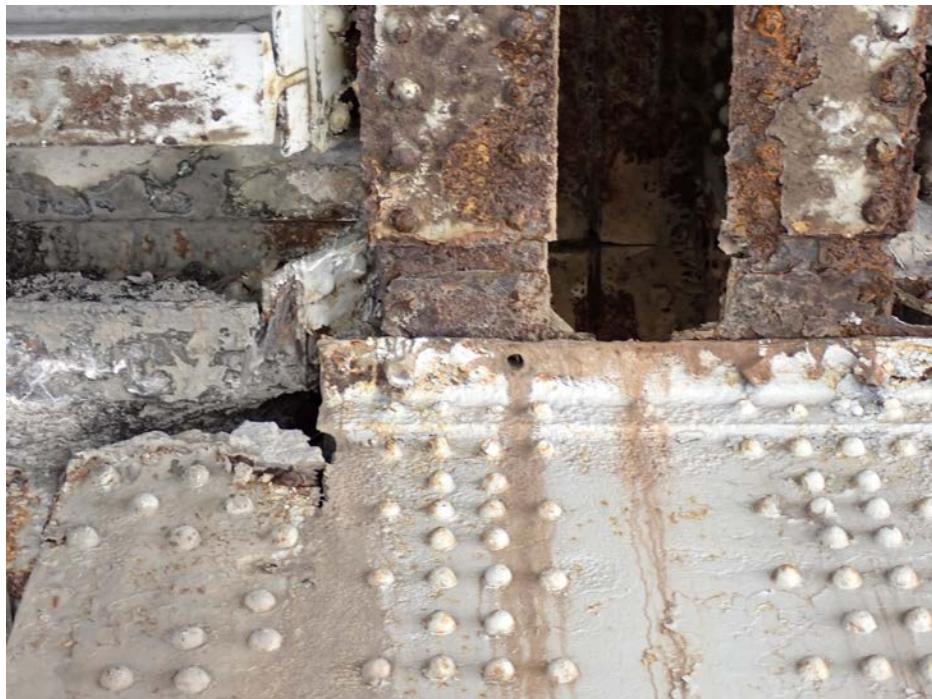
PHOTO 4

Bearing areas on piers exhibit paint failure with moderate to heavy laminate corrosion and isolated missing bolts.

Description Missing bearing fastener in Span 2 Girder 6 at Pier 2, looking east.

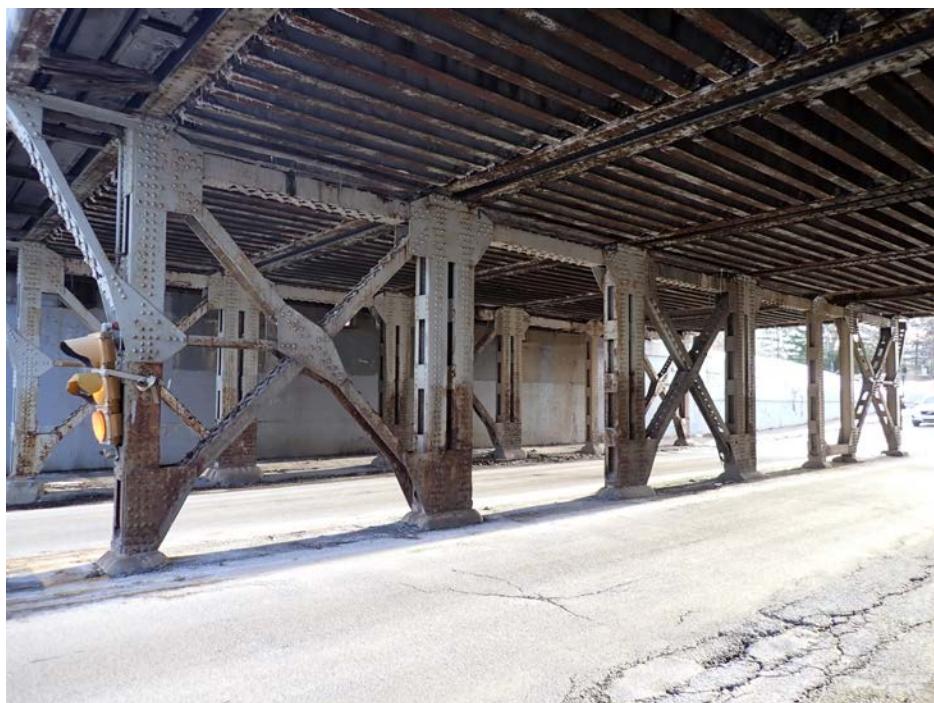
PHOTO 4

Description Pier 2 elevation, looking southeast.

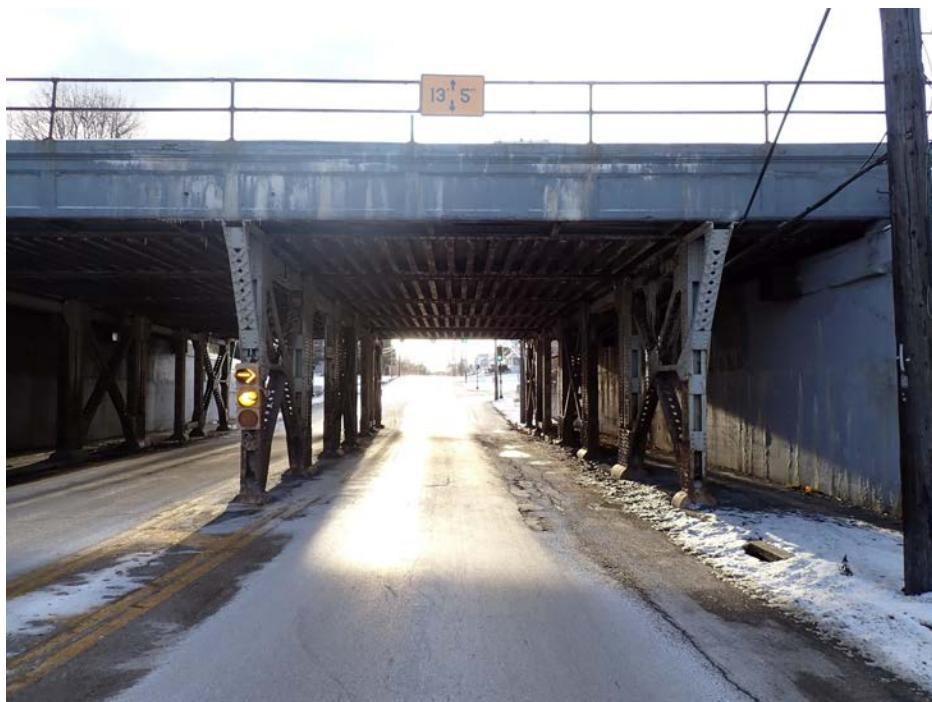
PHOTO 4

Description Roadway under view in Span 2 (Lake Avenue), looking south.

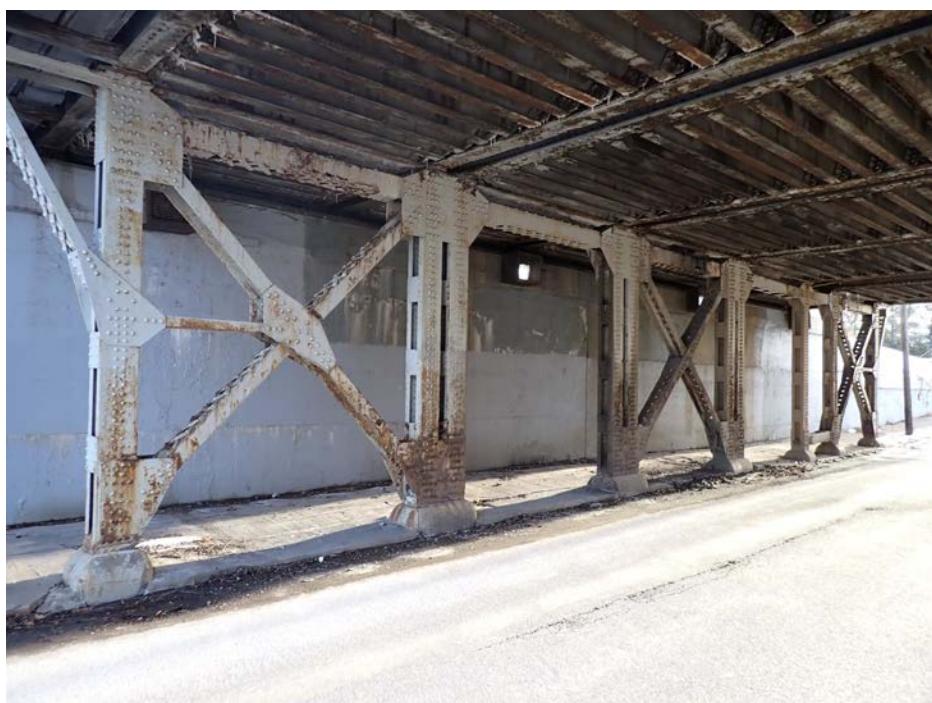
PHOTO 5

Description Pier 3 elevation, looking southeast.

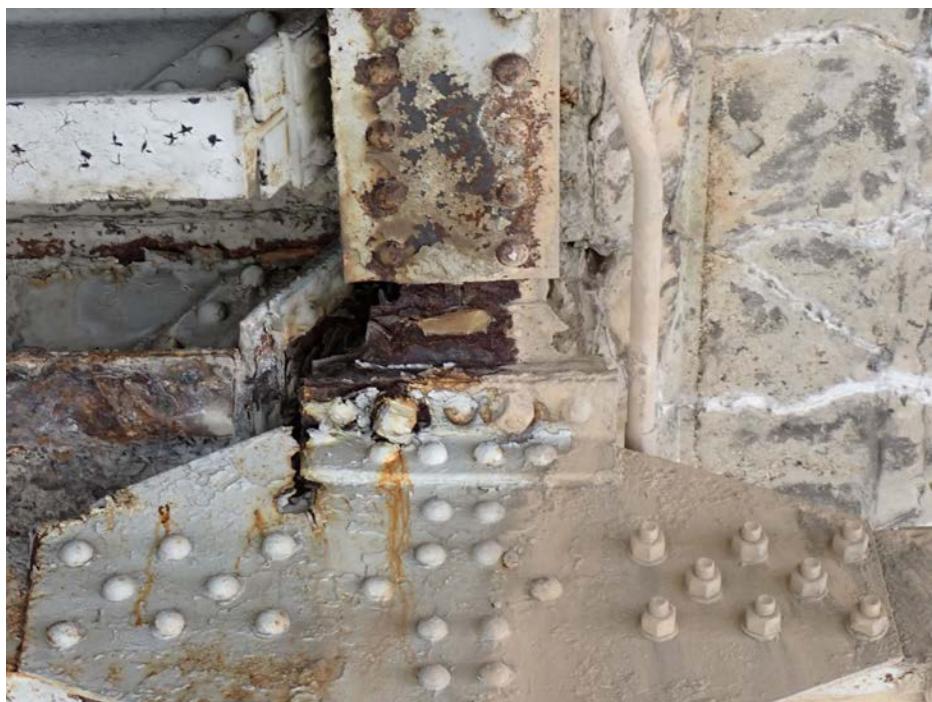
PHOTO 5

Description Edge loss of Girder 8 bottom flange in Span 2 at Pier 2, looking east.

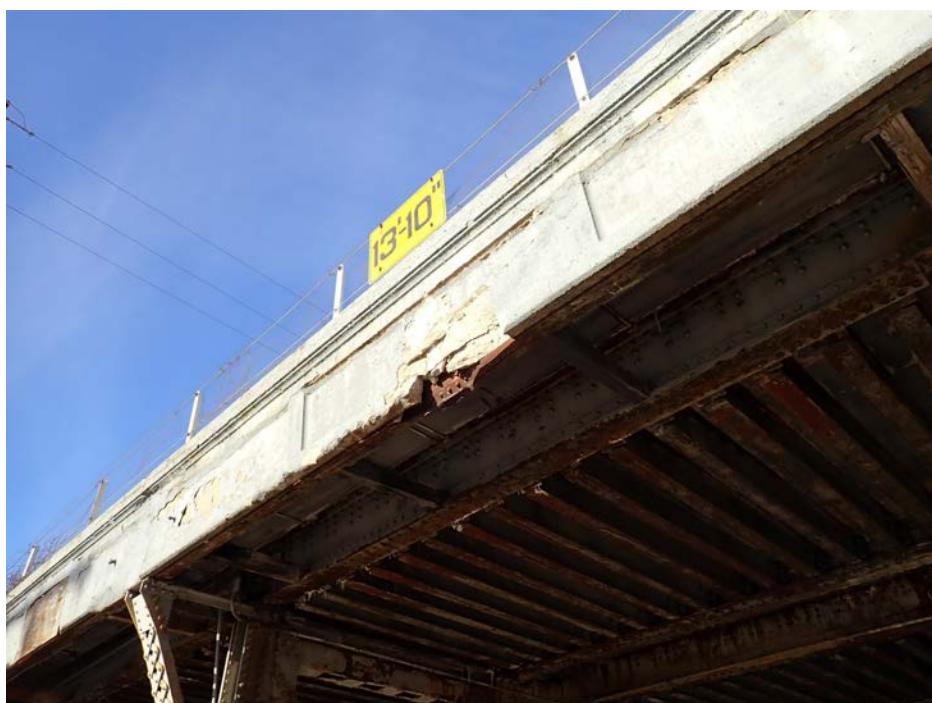
PHOTO 6

The exterior fascia auxiliary girders are concrete encased. Concrete encasement exhibits widespread moderate cracks with moderate to heavy efflorescence and isolated minor spalls. South fascia auxiliary girder has heavy impact damage over northbound lane with approximately 4' long by 3' high by up to full depth impact spall that has fully exposed the bottom flange and lower portion of the web which is bent northward approximately 2" over 5' length and south bottom flange outstanding leg is torn full width over a 2' length.

Description Impact damage to south auxiliary beam over Span 3, looking northwest.

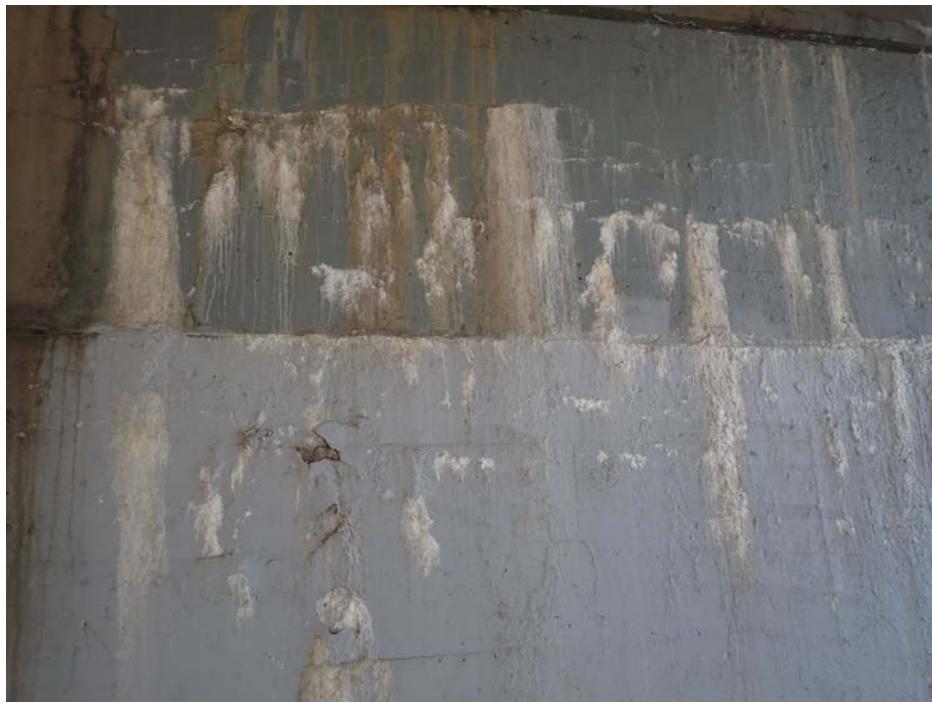
PHOTO 6

The concrete abutments have widespread insignificant to medium horizontal cracks with areas of heavy efflorescence buildup, shallow delaminations, and isolated patches. The abutment caps have isolated wide horizontal delamination cracks along the top edge. Concrete wingwalls have medium random cracks, light efflorescence and isolated light rust staining, delaminations and spalls.

Description Efflorescence buildup on Rear Abutment below Beams 2 and 3, looking west.

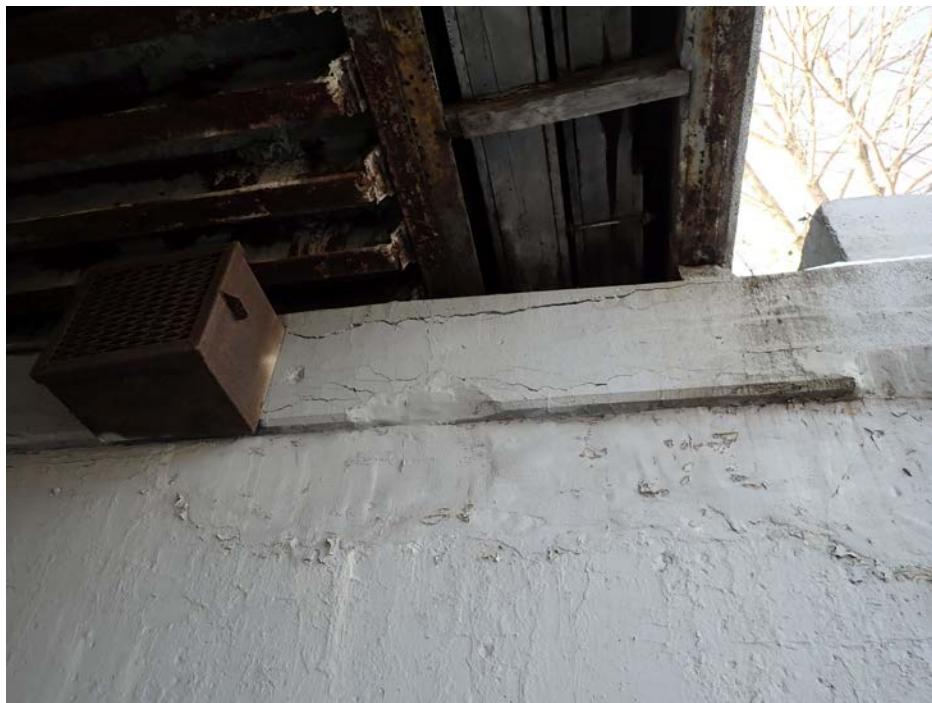
PHOTO 7

Description Wide horizontal delamination crack in Rear Abutment cap at Girder 1, looking west.

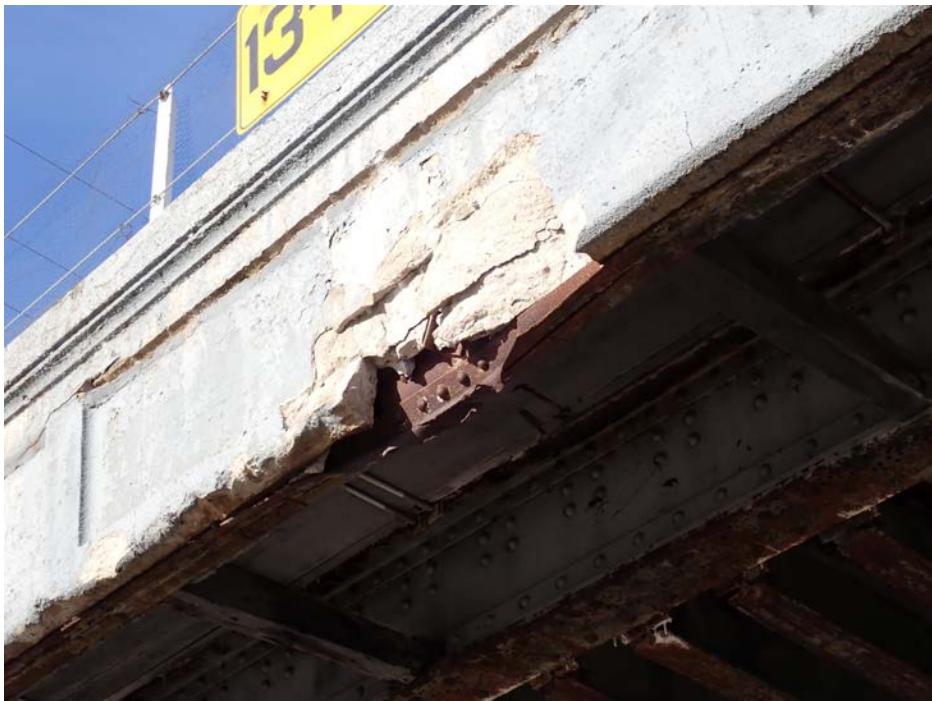
PHOTO 7

Description Detail view of impact damage to south auxiliary beam over Span 3, looking northwest.

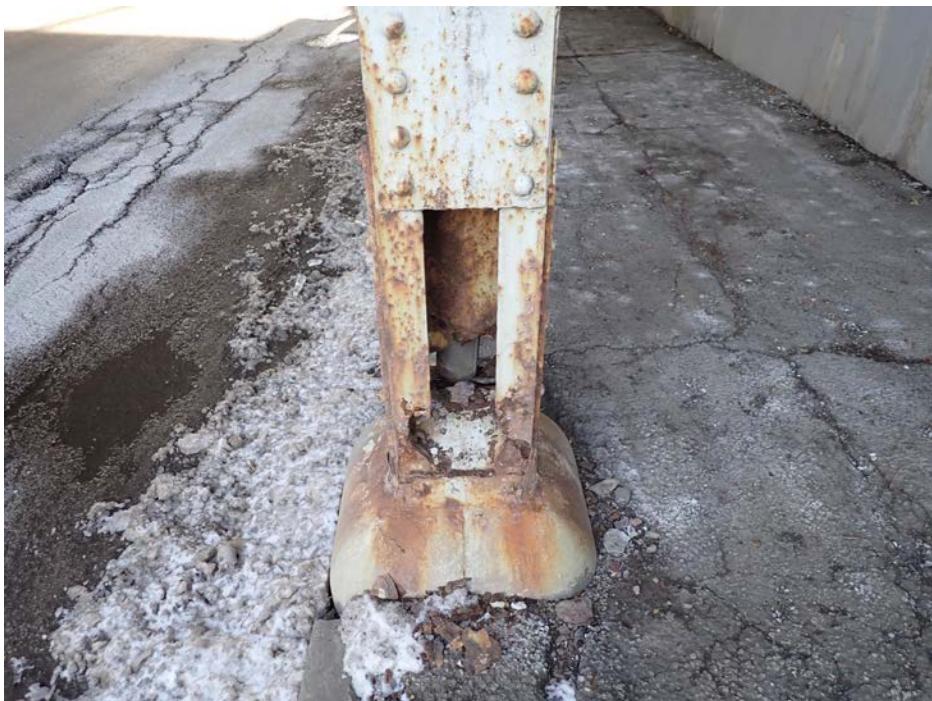
PHOTO 8

The steel piers have widespread paint failure with laminate rust and advanced section loss. The steel columns have laminate rust and section loss near their bases, with areas of 100% section loss to the outstanding legs up to full width and isolated holed-through web plates up to full width. The pier bracing has widespread heavy laminate rust with holed-through sections noted in the angles and lacing bars. Pier top struts have heavy laminate corrosion and section loss with isolated holed-through sections. Pier bracing connection plates (original thickness 7/16") have advanced section loss and holed-through sections, worst near their bases and along the edges. Select steel substructure components (columns, bracing members, bracing connection plates) have been previously replaced with select replaced bracing connection plates having advanced section loss and holed-through sections.

Description Up to 100% section loss to channel legs and web plate at base of Column 1 in Pier 1, looking south.

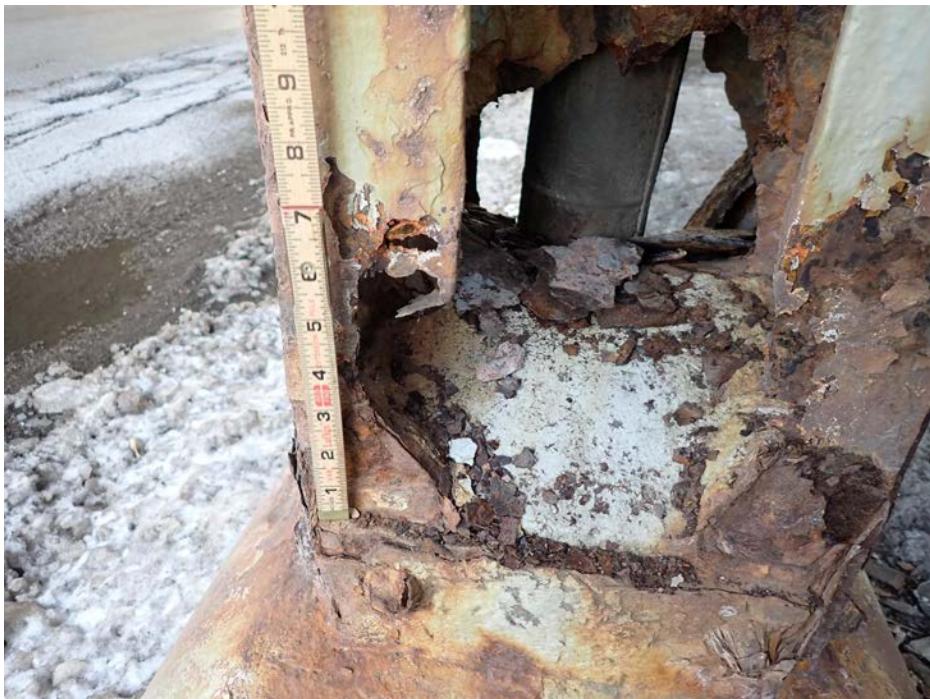
PHOTO 9

Description Detail view of up to 100% section loss to channel legs and web plate at base of Column 1 in Pier 1, looking south.

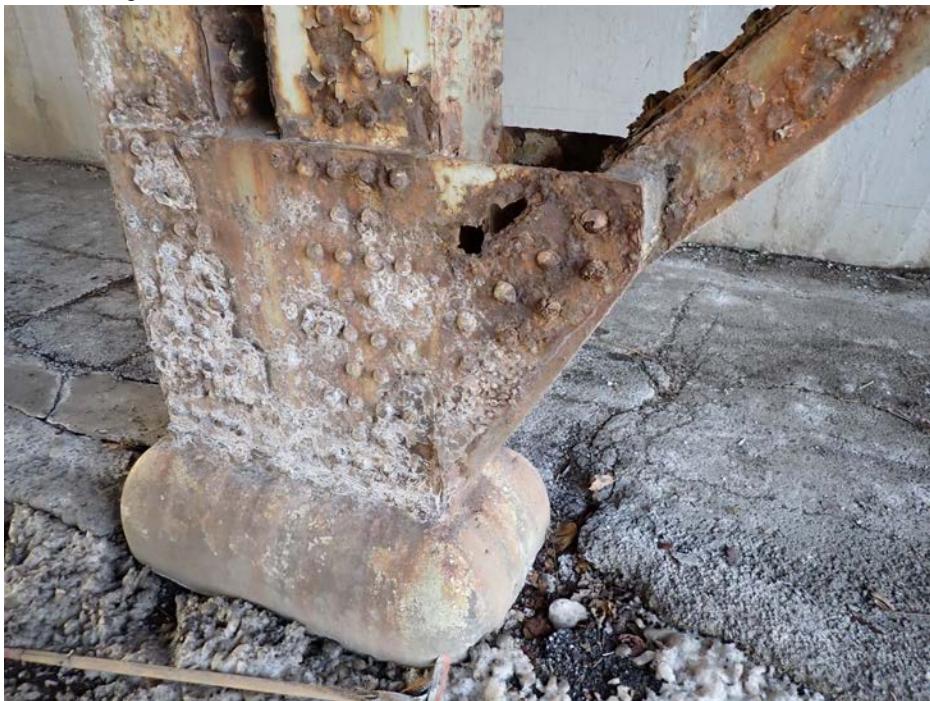
PHOTO 10

Description Holed-through sections on bracing connection plate at base of Column 2 in Pier 1, looking west.

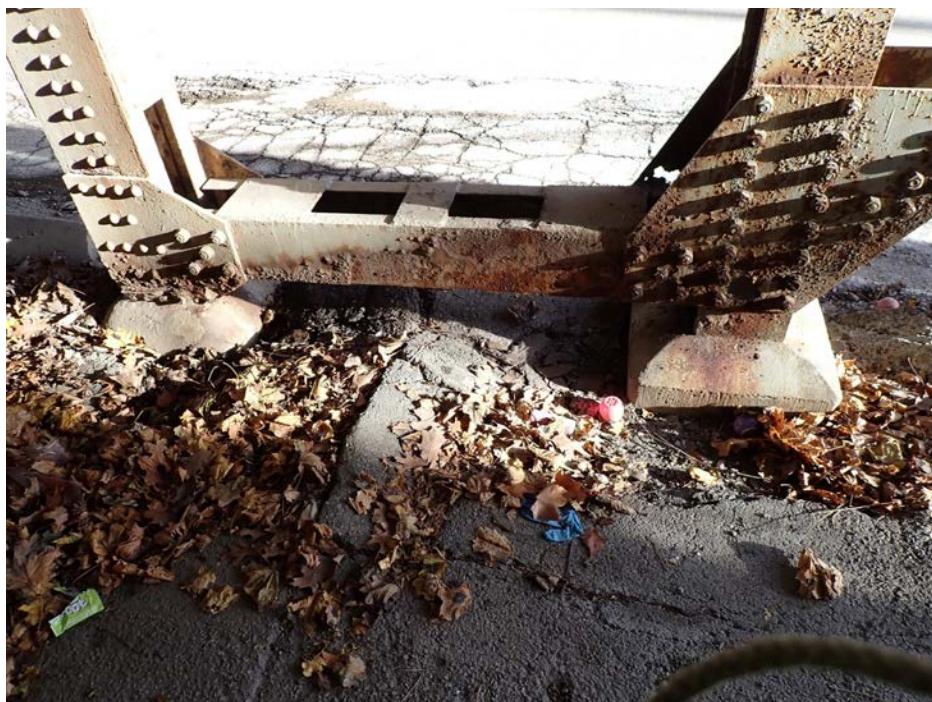
PHOTO 11

The City Manager had previously indicated that the concrete foundations exhibited movement under the passage of trains and provided a video from May 2025 showing minor vertical movement (~1/2"). Three train passages occurred during the 2025 cursory inspection with no movement observed; however, the sidewalks are broken up around the column bases, which is indicative of prior foundation movement.

Description Sidewalks broken up around column bases of Columns 8 and 9 at Pier 1, looking east.

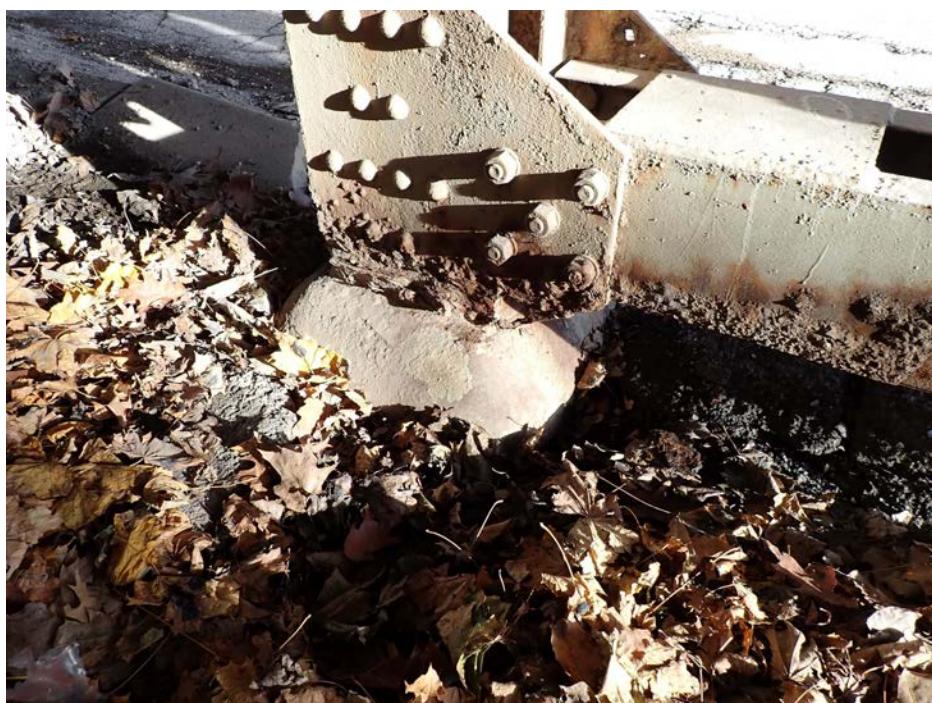
PHOTO 12

Description Detail view of sidewalks broken up around column bases of Columns 8 and 9 at Pier 1, looking east.

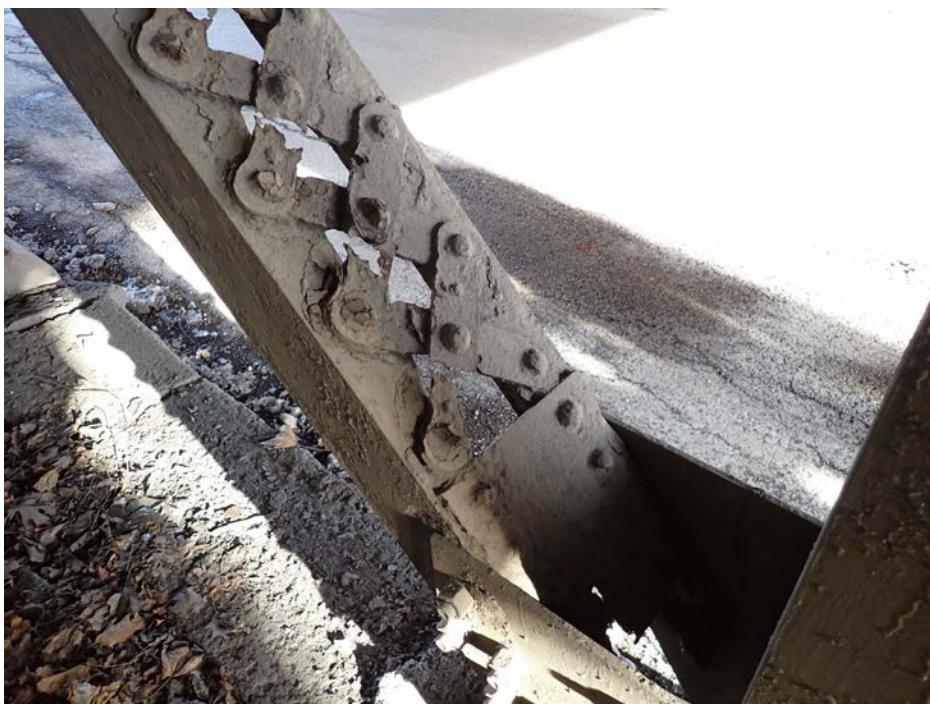
PHOTO 13

Description Diagonal brace with 100% section loss to angle legs and batten plate at Column 6 in Pier 1, looking east.

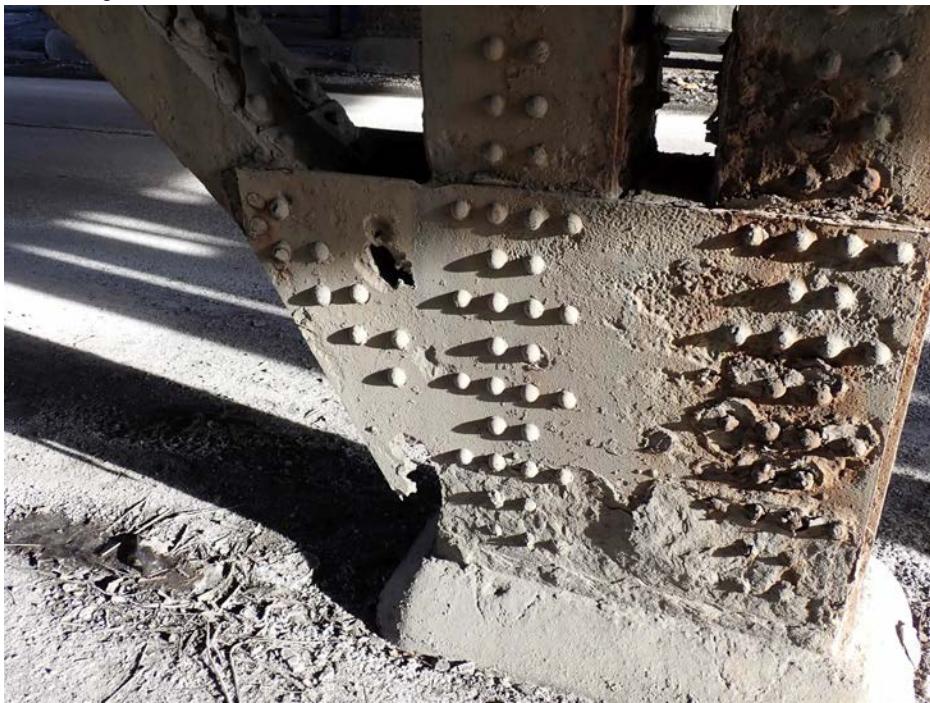
PHOTO 14

Description Holed-through sections in bracing connection plate at base of Columns 6 and 7 in Pier 2, looking east.

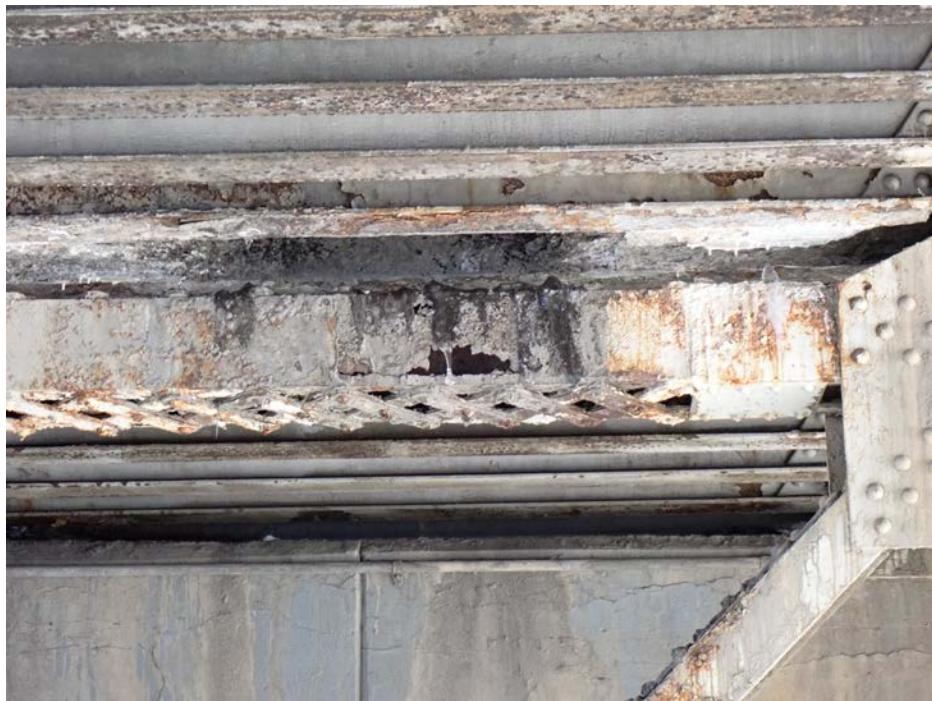
PHOTO 15

Description Holed-through section in top strut between Columns 5 and 6 in Pier 3, looking east.

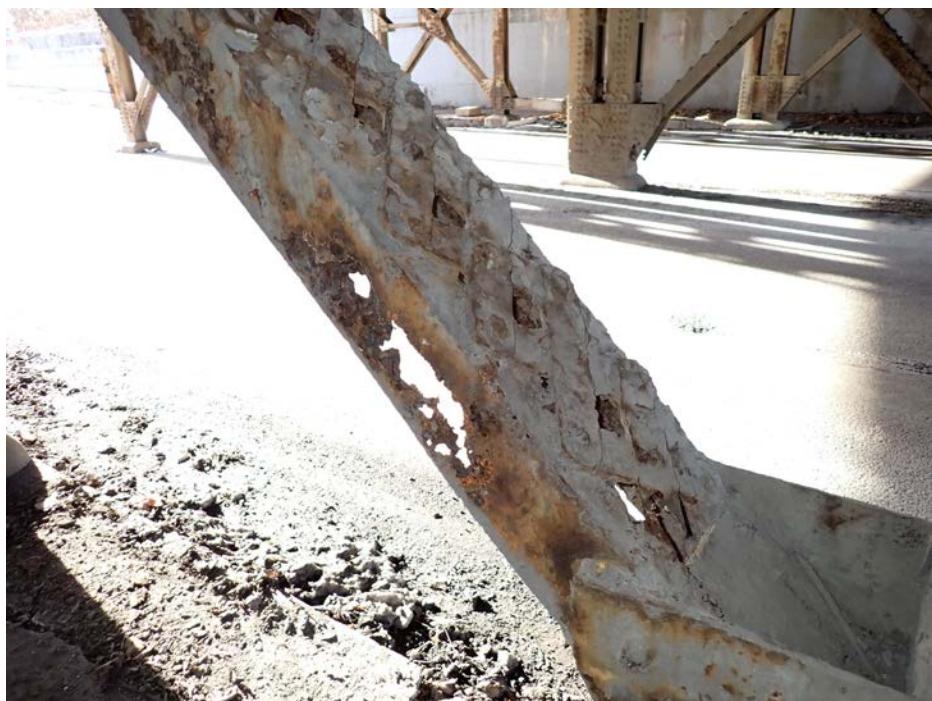
PHOTO 16

Description Holed-through section in diagonal brace at Column 5 in Pier 3, looking west.

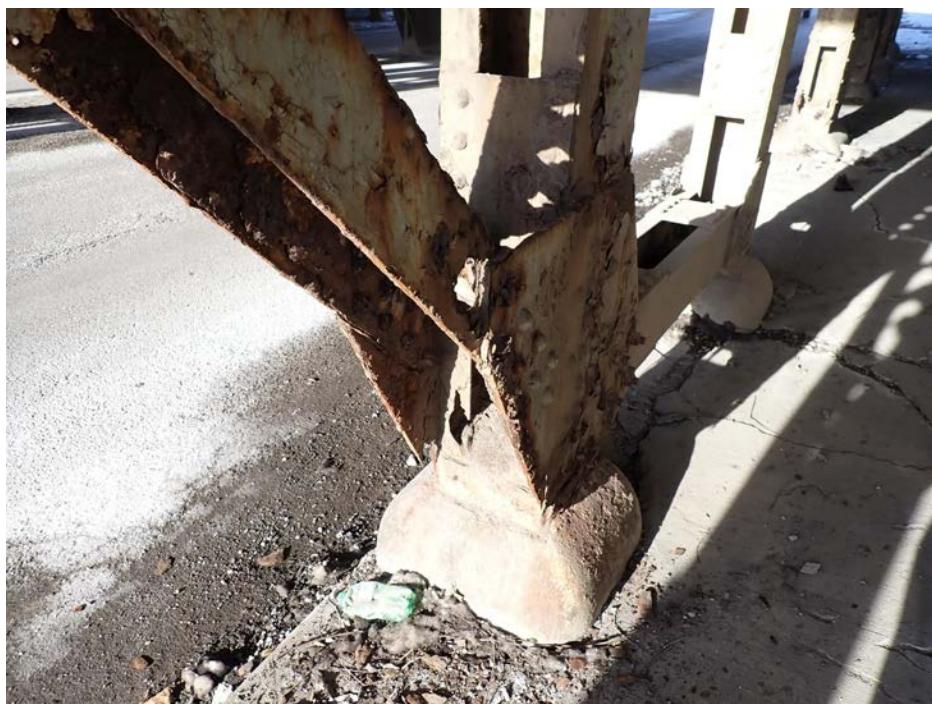
PHOTO 17

Description Holed through section at base of Column 9 in Pier 3, looking northwest.

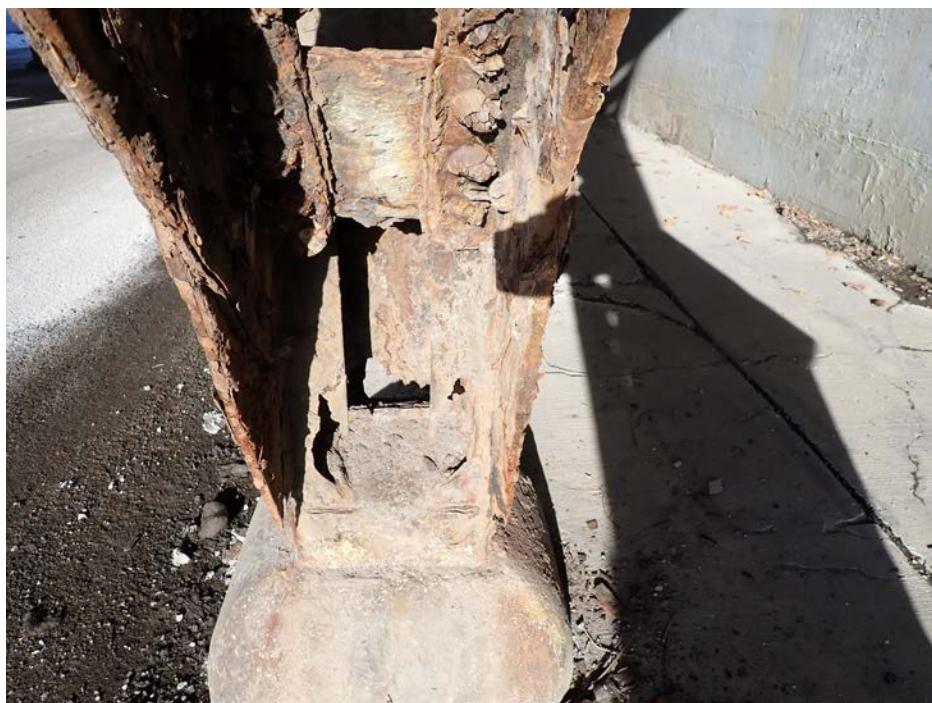
PHOTO 18

Description Detail view of holed through section at base of Column 9 in Pier 3, looking north.
